# Home Inspection Report

6543 First Ave. Missouri City, TX 77459

# PROPERTY INSPECTION REPORT

**Inspection Date:** 05/02/2020

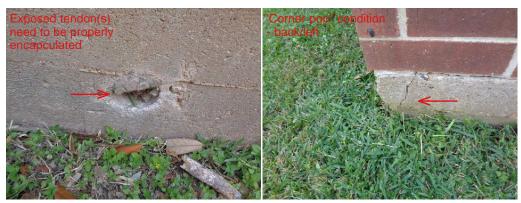
- Exposed tension rods need to be properly encapsulated to prohibit rust damage.
- "Corner pop" noted on back/left side of foundation Corner pop conditions are considered cosmetic (non structural) conditions.

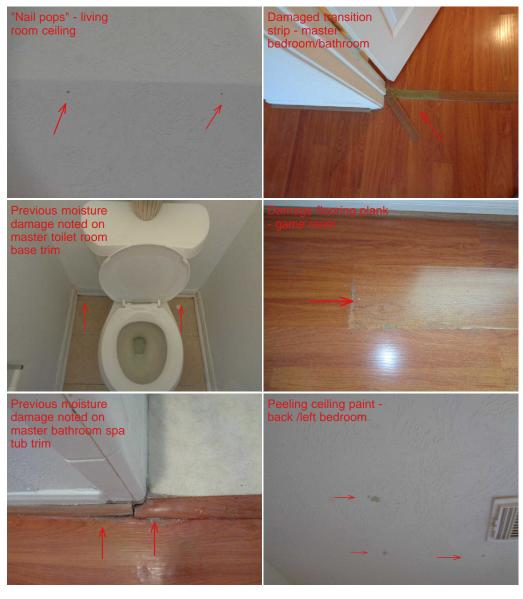
**F.** Ceilings and Floors - Comments: - Nail pops noted in living room ceiling.

- Paint peeling in left/back bedroom possibly from removal of reflective stickers.
- Damaged transition between master bedroom and bathroom needs repair.
- Previous water damage on base trim noted in and around master bathroom tub and toilet.
- Moisture damage (floor planks are curling master bedroom and game room floor needs repair.

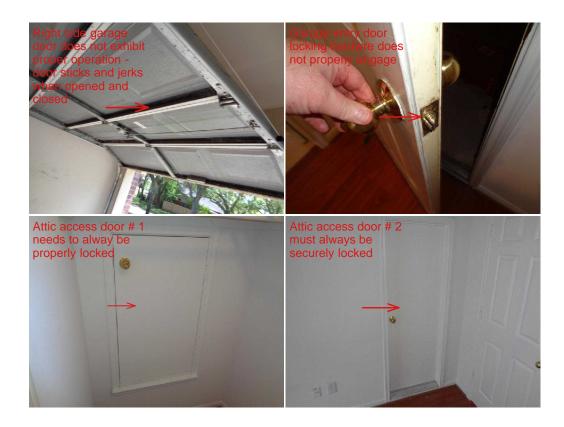
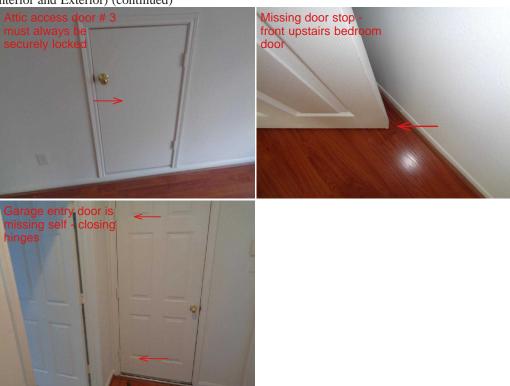
- - Right side garage door does not properly/smoothly open. has jerky movement needs lubrication and adjustment.
  - Garage entry door is missing proper self closing hinges needs repair.
  - Garage entry door locking mechanism does not engage needs replacement.
  - Door stop missing on front upstairs front bedroom door need replacement.

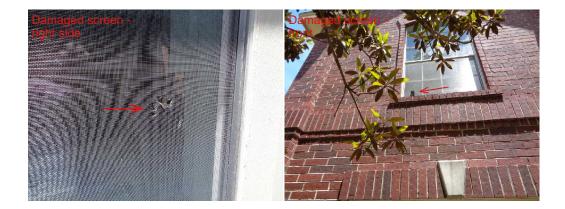
H. Windows - Comments: - Aluminum single pane, - Damaged window screens noted on front window and right side window - need replacement.

- Damaged glazing strip right upstairs window needs repair.
- Missing screens need replacement.

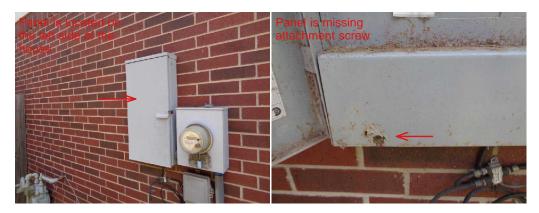
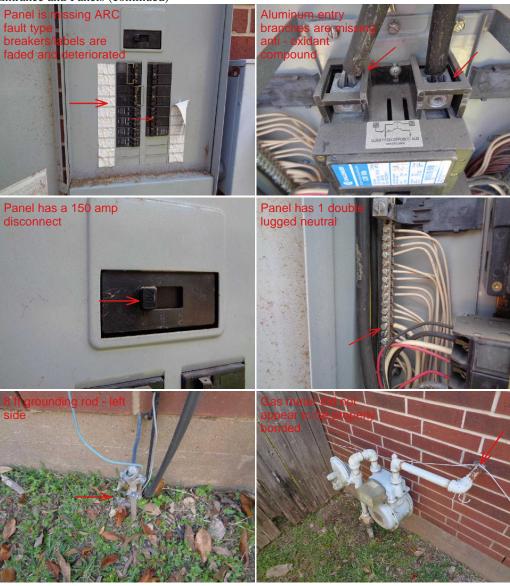
▲ Service Entrance and Panels - Comments: - Aluminum, - The panel is located on the left side of the house.

- The panel has a 150 amp disconnect which is adequate for this size of house.
- The panel is missing an attachment screw needs replacement.
- Panel labels are fading/deteriorated should be replaced with new typed labels that will not fade.
- The panel is missing proper ARC fault type breakers needs repair.
- The panel appears to have aluminum entry branches.
- The aluminum entry branches do not appear have anti oxidant compound which prohibits oxidation needs repair.
- The electrical system appears to be properly grounded via an 8 ft. grounding rod.
- The gas meter does not appear to be properly bonded.
- The panel appears to have double lugged neutral (double lugged neutrals can cause excessive heat in the panel) needs repair.

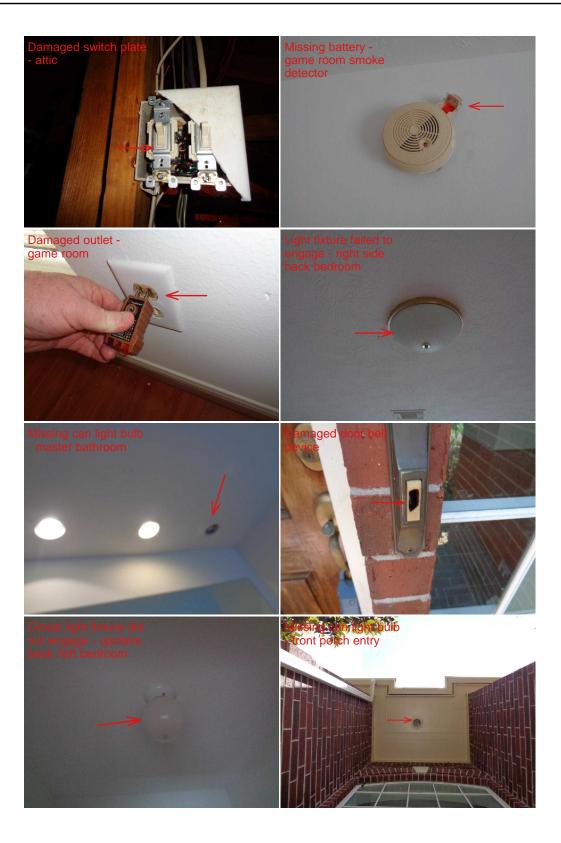
Comments: - Copper - Damaged switch plate note in attic - needs replacement.

- Batteries missing in game room smoke detector needs replacement.
- Upstairs outlet has obstructed/damaged pin needs replacement.
- Can light out master bathroom needs replacement.
- Doorbell device is damaged needs repair/replacement.
- Light bulb out upstairs closet needs replacement.
- Light bulbs out middle/right side bedroom needs replacement.
- Light bulb missing front porch exterior light needs replacement. Page 11 of 24

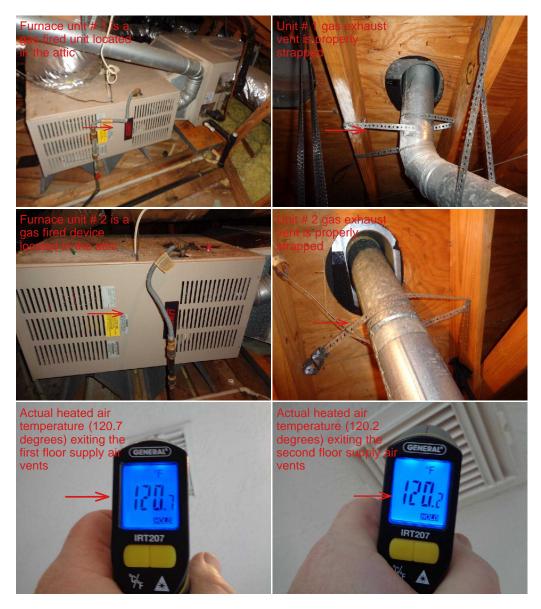
Comments: - Lennox - Both furnaces are gas fired units located in the attic.

- Both furnace gas exhaust vents appear to be properly strapped.
- Heating systems appeared to be functioning as designed. Heated air exiting the supply air vents exceeded 120 degrees vs an ambient air temperature of 80 degrees produces a differential of 40 degrees which is acceptable per industry standards.
- Both furnace units were manufactured in 1995 and are past their respective designed life cycles.

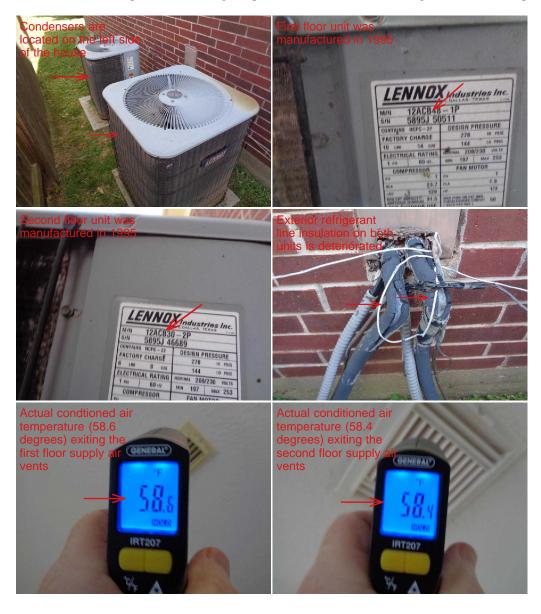
Comments: - Lennox - Both condensers are located on the left side of the house.

- Both condensers and both attic coil packages were manufactured in 1995 and are past their designed life cycles.
- The exterior insulation on portion of both refrigerant lines is deteriorated needs replacement.
- Both A/C systems appeared to be functioning as designed. Conditioned air exiting the supply air vents exceeded 58 degrees vs an ambient air temperature of 80 degrees produces a differential of 22 degrees which is acceptable per industry standards.

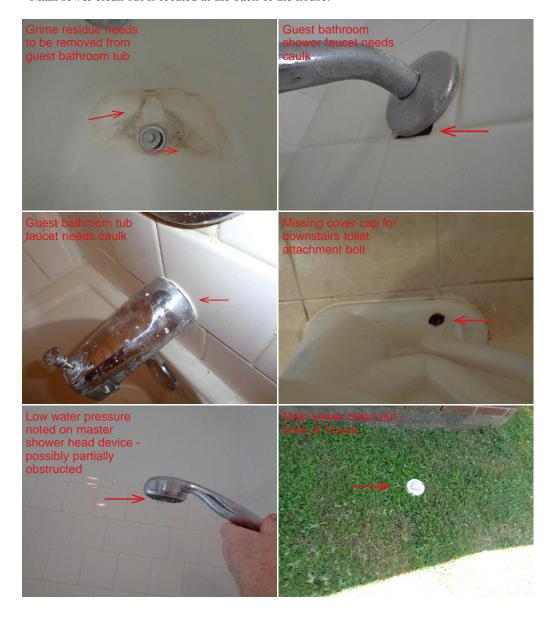
B. Drains, Wastes, and Vents - Comments: - PVC, - Upstairs tub is dirty/dingy - needs to be properly cleaned.

- Missing clear caulk application on upstairs tub water faucet features needs repair.
- Damaged tile/missing caulk upstairs guest bathroom shower head needs repair.
- Missing toilet bolt cover cap downstairs guest bathroom needs replacement.
- Low water pressure noted on master shower head assembly ( possibly partially obstructed) needs replacement.
- Main sewer clean out is located at the back of the house.

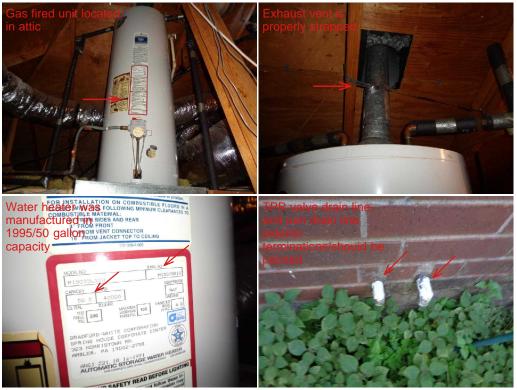
Comments: - Bradford White - The water heater is a gas fired unit located in the attic.

- The water heater was manufactured in 1995 and is past its designed life cycle needs replacement.
- The water heater has both TPR drain line and pan drain line exterior terminations need paint.
- The water heater gas exhaust vent appears to be properly strapped.

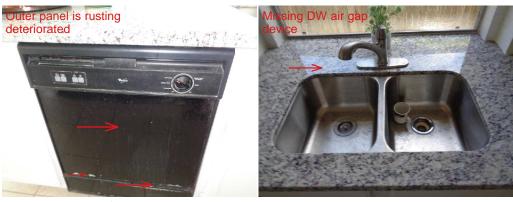
- A. Dishwashers Comments: Whirlpool, Dishwasher is missing an air gap or high loop device to prevent cross contamination needs repair.
  - Dishwasher outer panel is exhibiting signs of rust existing beyond typical design life-limited life needs replacement.

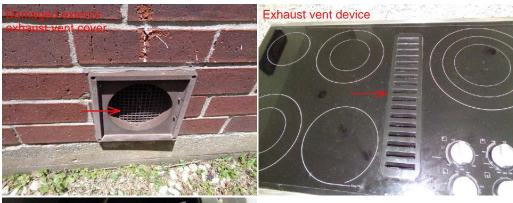
C. Range Hood and Exhaust Systems - Comments: - Jenn-air, - Missing exterior exhaust vent cover plate - needs repair.

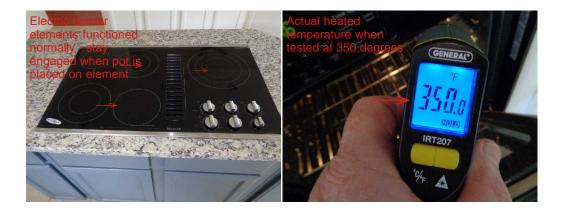
- D. Ranges, Cooktops, and Ovens Comments: Jenn-Air, Electric burner elements appeared to function properly at the time of the inspection.- Stay operative when pan is placed on element.
  - Oven was tested at 350 degrees and had 0 degree variance at the time of the inspection.
  - Oven existing beyond typical design life-limited life needs replacement.
  - Outer casing on oven is damaged/scratched.

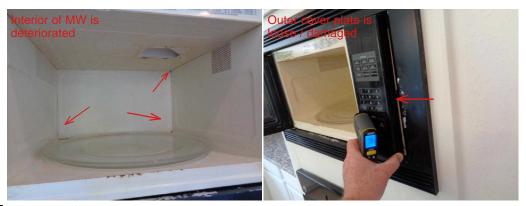
**E. Microwave Ovens** - Comments: - Whirlpool, - Microwave existing beyond typical design life-limited life - needs replacement.

- Outer cover plate is loose.
- Interior of unit appears to be deteriorated/damaged.
