Home Inspection Report

789 Elm St. Richmond, TX 77407

PROPERTY INSPECTION REPORT

Inspection Date: 02/19/2020

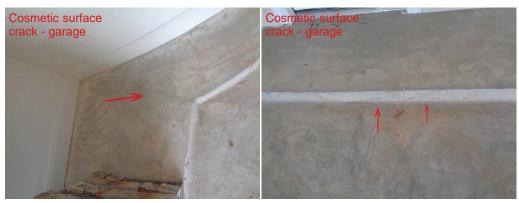
- Cosmetic surface cracks noted in garage.

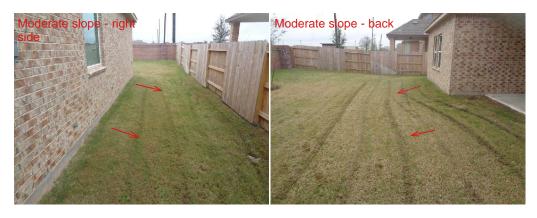
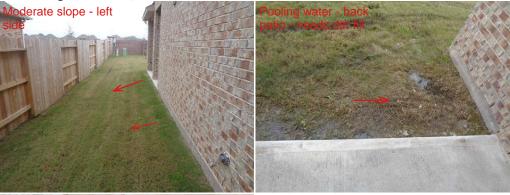
- Pooling water was noted on back and left side of house - needs dirt fill.

- Pooling water was noted on back and left side of house needs dirt fill.
- E. Walls (Interior and Exterior) Drywall/Stone/Brick Veneer/Hardiplank, Exterior expansion joints appear to be properly sealed.

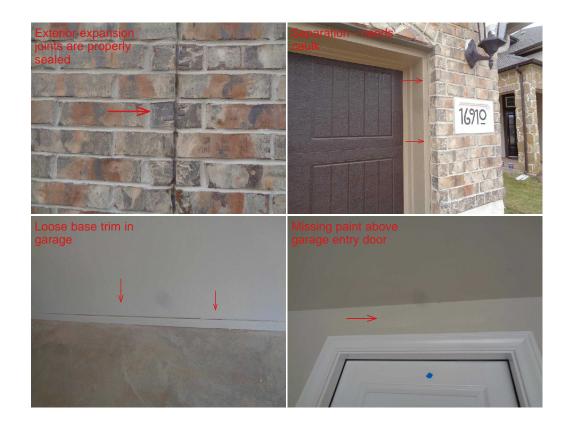
- Separation crack noted between garage wood trim and brick cladding needs caulk.
- Wood base trim on right side of garage interior is loose needs to be properly attached and caulked.
- Missing wall paint above garage entry door (garage side0 needs repair.
- Damaged to half bath vanity cabinet needs repair.

- Separation crack noted between garage wood trim and brick cladding needs caulk.
 - Wood base trim on right side of garage interior is loose needs to be properly attached and caulked.

- Missing wall paint above garage entry door (garage side0 needs repair.
 - Damaged to half bath vanity cabinet needs repair.
- F. Ceilings and Floors Tape seam cracks noted in upstairs game room closet ceiling need repair.

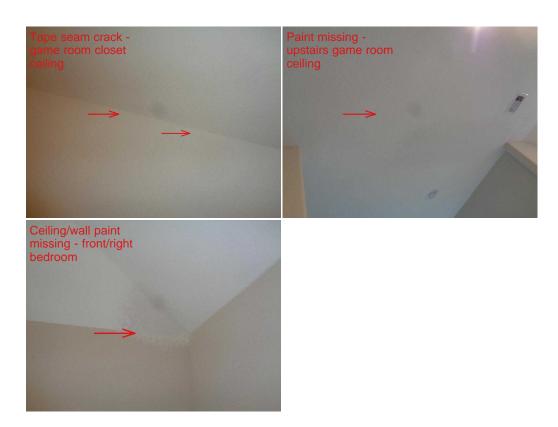
F. Ceilings and Floors - Comments: - Tape seam cracks noted in upstairs game room closet ceiling - need repair.

- Missing paint on upstairs game room ceiling needs repair.
- Missing paint on upstairs bedroom ceiling needs repair.
- Paint missing upstairs game room ceiling.

- Missing paint on upstairs game room ceiling needs repair.
 - Missing paint on upstairs bedroom ceiling needs repair.
 - Paint missing upstairs game room ceiling.

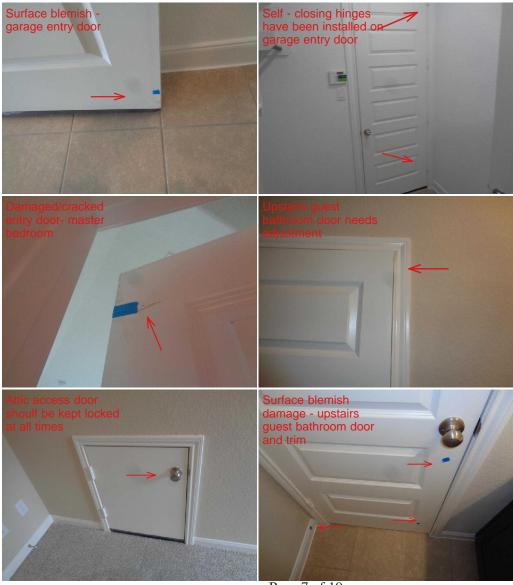
G. Doors (Interior and Exterior) - Comments: - Solid wood and hollow core. - Damage to garage entry door needs repair.

- Self closing hinges on garage entry door are functioning properly.
- Damage to master bedroom door needs repair/replacement.
- Upstairs guest bathroom door "sticks" needs adjustment.
- Surface blemishes to upstairs guest bathroom door and wall trim needs repair.
- Upstairs attic access door should be kept locked at all time and the key stored in a separate location.

- G. Doors (Interior and Exterior) Solid wood and hollow core. Damage to garage entry door needs repair.
 - Self closing hinges on garage entry door are functioning properly.

- Damage to master bedroom door needs repair/replacement.
 - Upstairs guest bathroom door "sticks" needs adjustment.
 - Surface blemishes to upstairs guest bathroom door and wall trim needs repair.

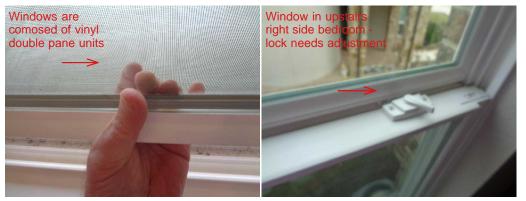
H. Windows - Comments: - Vinyl double hung/double pane, - Upstairs right side window latch needs adjustment - Does not properly latch.

- Upstairs attic access door should be kept locked at all time and the key stored in a separate location.
- H. Windows Vinyl double hung/double pane, Upstairs right side window latch needs adjustment Does not properly latch.

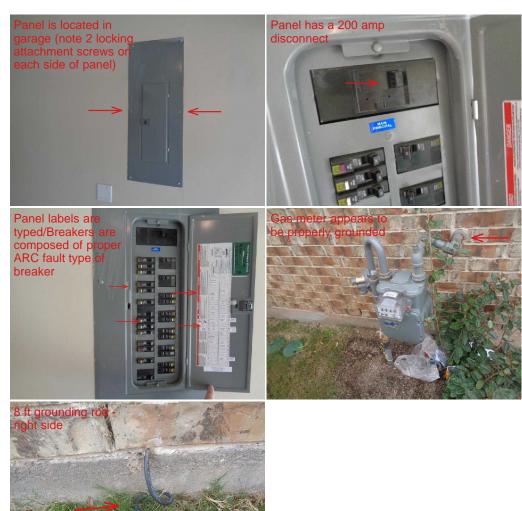
A. Service Entrance and Panels - Comments: - Aluminum, - The panel is located in the garage.

- The panel has a 200 amp disconnect which is adequate for the size of the house.
- The panel appears to have the required ARC fault breakers.
- The front cover could not be removed due to locking type attachment screws.
- The electrical system appeared to be properly grounded via a 8 foot grounding rod at the electrical meter. It was undeterminable if the home was properly grounded.
- The gas meter appeared to be properly bonded.

- A. Service Entrance and Panels Aluminum, The panel is located in the garage.
 - The panel has a 200 amp disconnect which is adequate for the size of the house.
 - The panel appears to have the required ARC fault breakers.
 - The front cover could not be removed due to locking type attachment screws.

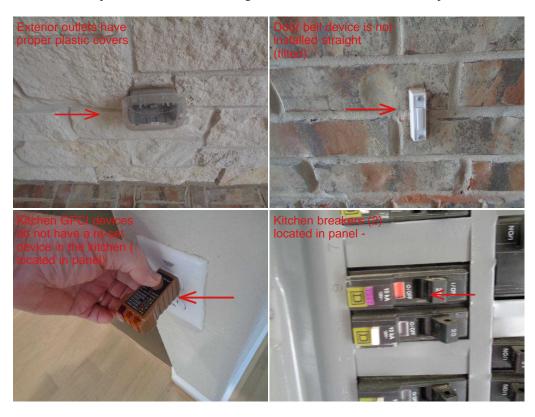
- Door bell device is not installed on a proper vertical position (tilte0 needs repair.
- Kitchen GFCI protected outlets are missing re- set device in kitchen needs repair.

- A. Service Entrance and Panels (continued)
 - The electrical system appeared to be properly grounded via a 8 foot grounding rod at the electrical meter. It was undeterminable if the home was properly grounded.
 - The gas meter appeared to be properly bonded.
- B. Branch Circuits, Connected Devices, and Fixtures Copper, Exterior outlets have the proper plastic covers.
 - Door bell device is not installed on a proper vertical position (tilte0 needs repair.
 - Kitchen GFCI protected outlets are missing re- set device in kitchen needs repair.
