Homesmith Home Inspections

321 First St. Houston, TX 77059

PROPERTY INSPECTION REPORT

Prepare	ed For:	Sam Jones		
Concer	ning:	321 First St. Houston	, TX 77059	
Inspect	ion Date:	04/18/2020		
By:	Inspector N Signature:	lame: Todd Duff	License Number: 21107	Date: 11/01/2014
	Sponsoring	Inspector: N/A	License Nu	mber 21107
	Phone: 713	-256-2498	E-Mail: ins	pector@homesmithhomeinspections.com

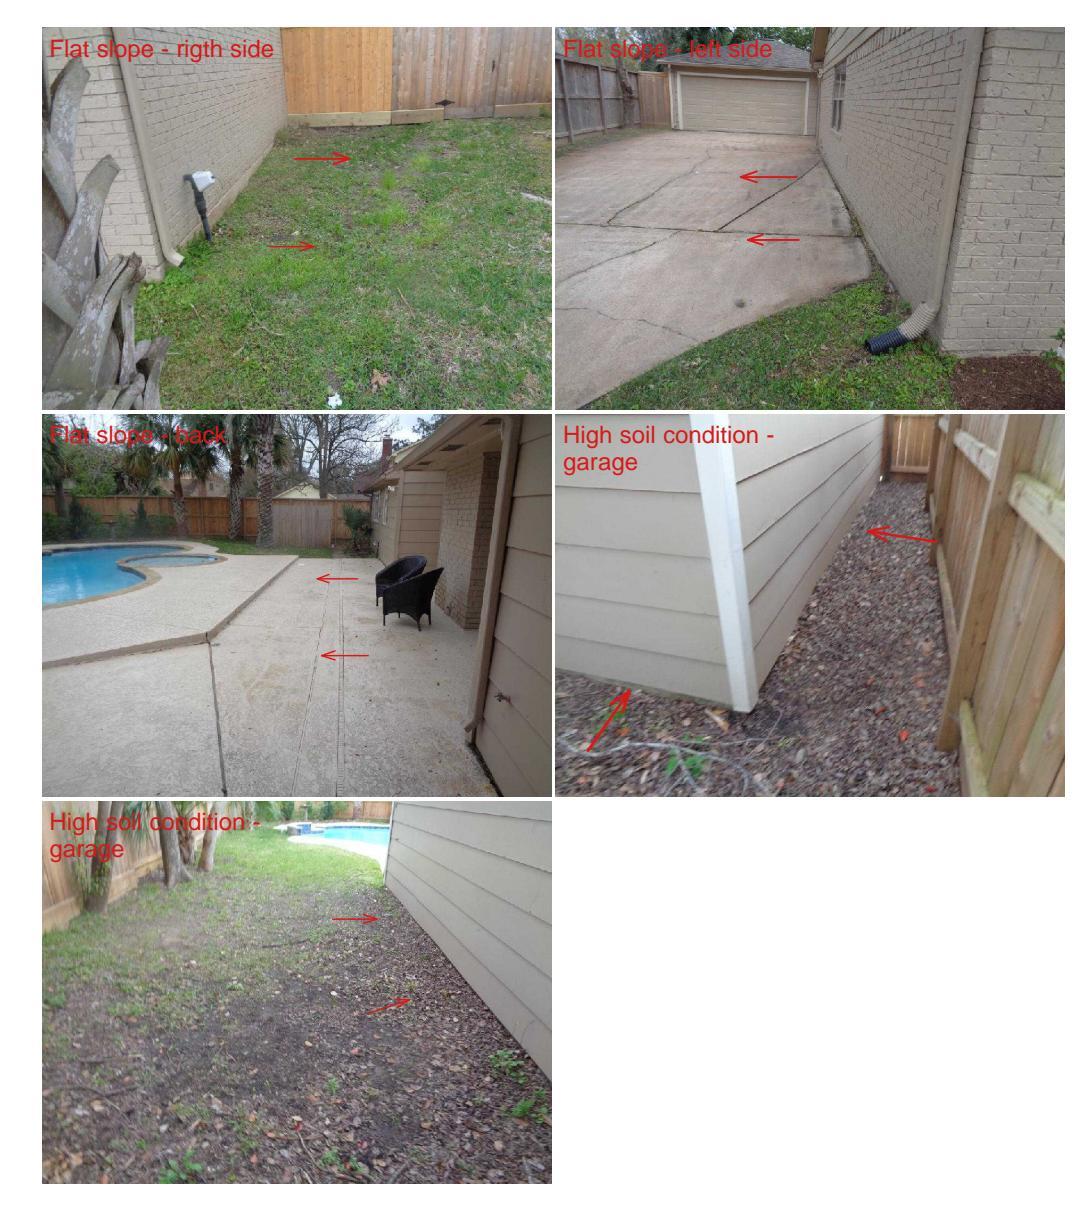
B. Grading and Drainage - Comments: - Flat slope, - Slope grade is adequate relative to the foundation. Existing ground elevation is 4-6 inches below the top of the slab which is acceptable for this situation.

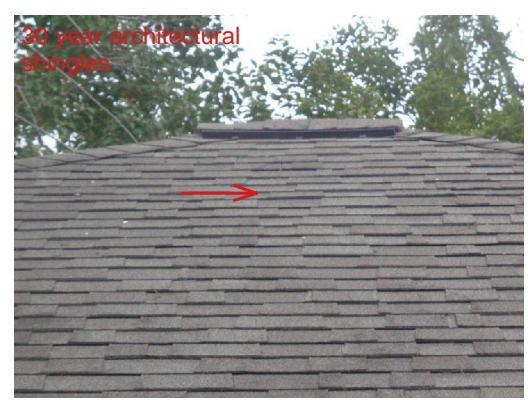
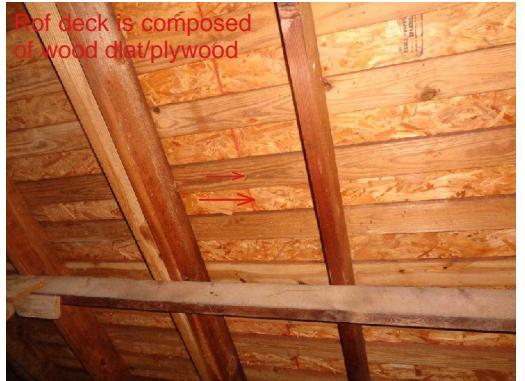
Comments: - 30 year architectural asphalt shingles - The roof is in overall good condition and performing as designed and installed.

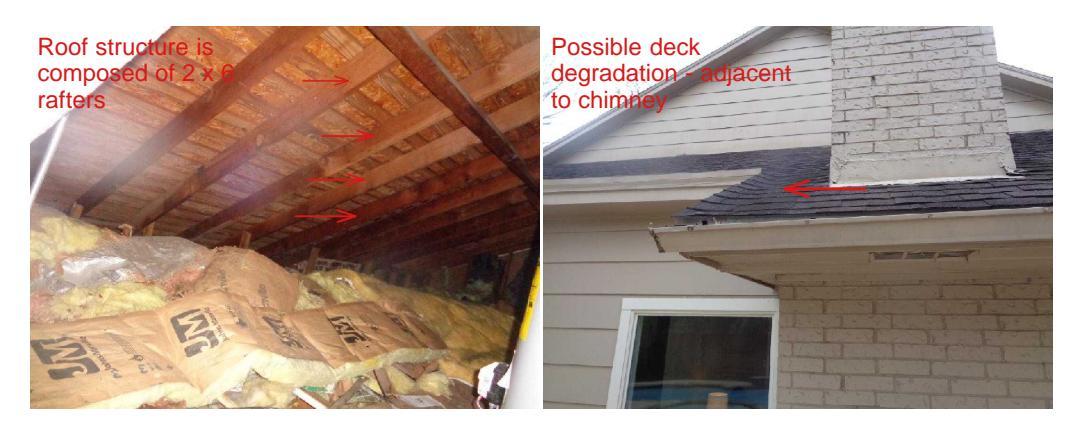
- Possible roof deck damage noted on back of roof adjacent to the chimney. Recommend further review by licensed roofing contractor.

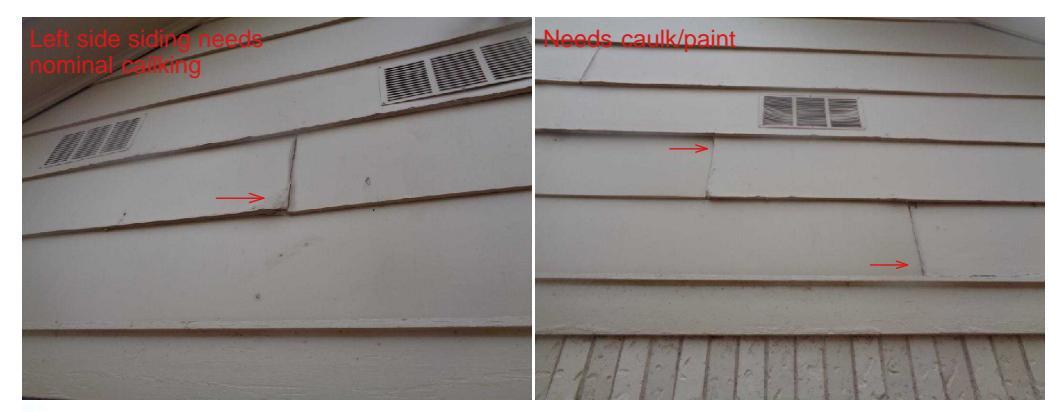
E. Walls (Interior and Exterior) - Comments: Drywall/Brick/Wood siding, - Nominal caulk needed in several siding locations.

- Damage vent cover noted on left side - needs repair.

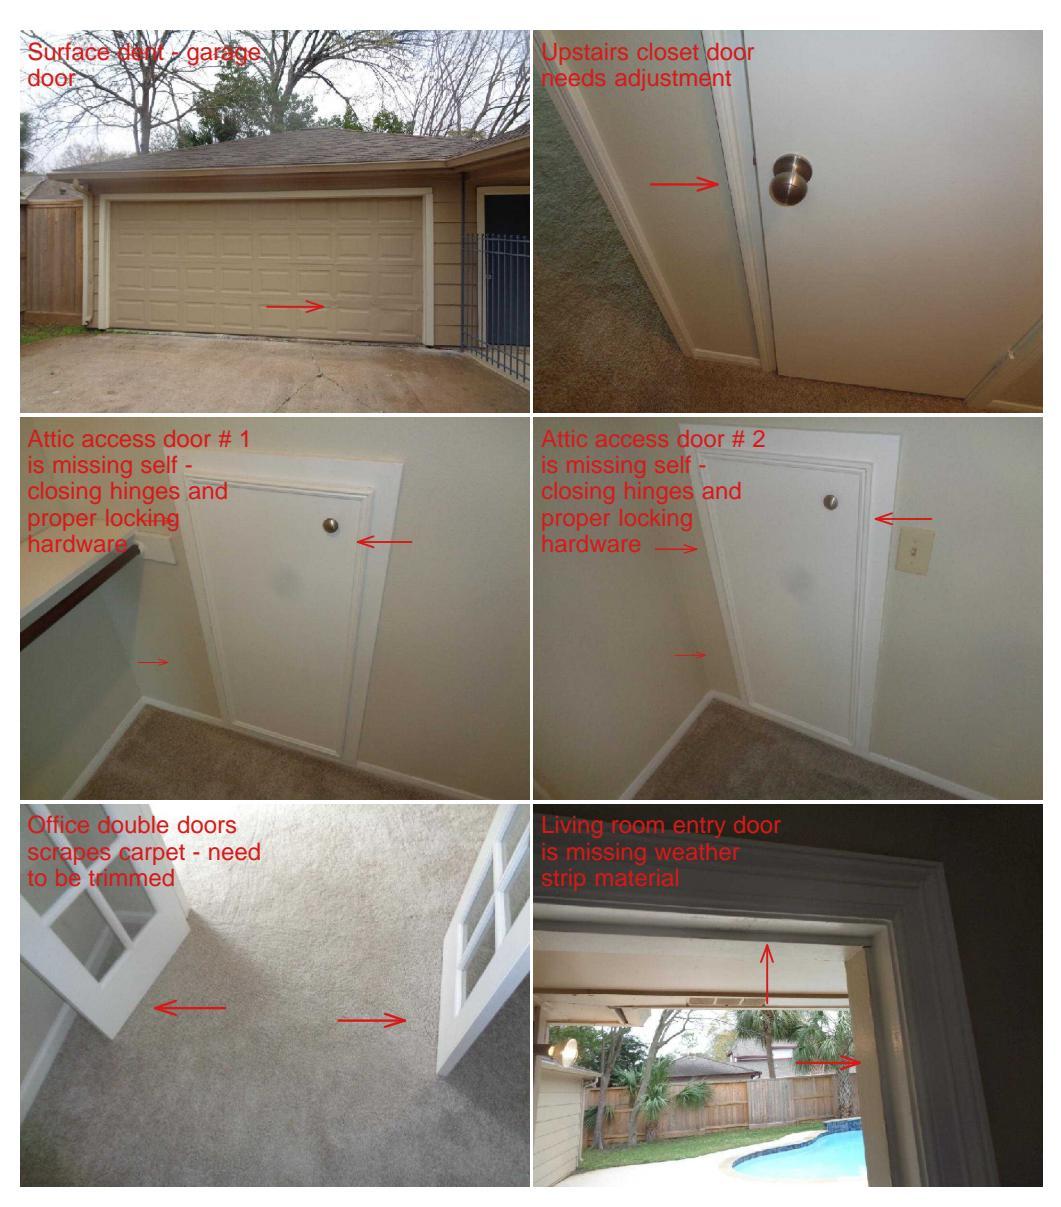
I NI NP D	
G. Doors (Interior and Exterior) - Comments: - Solid wood and hollow core Surface dent noted on garage door	r -

needs repair.

- Upstairs closet door needs adjustment.
- Both upstairs attic access doors are missing self closing hinges and proper locking hardware.
- Double doors in master office scrape carpet surface need adjustment.
- Liivng room entry door is missing weather strip material needs repair.

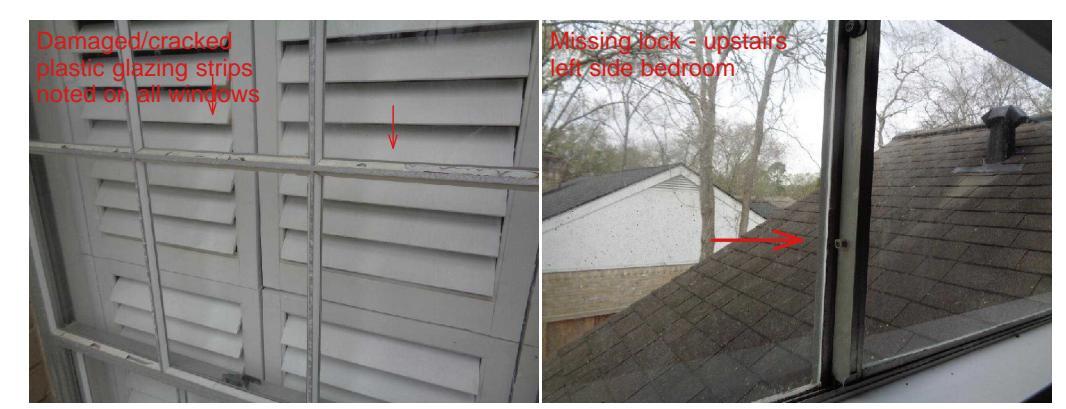
1 inspected	itiz ittör inspected	112 1100 11000110	2 2011010110	
I NI NP D				
	Windows - Comments: -	Aluminum double hung	g - single pane,	- Damaged plastic glazing strips noted on most windows
- nee	eds repair.

- All window screens are missing need replacement.
- Storm window noted on breakfast room window.
- Missing locking mechanism upstairs left side bedroom needs repair.

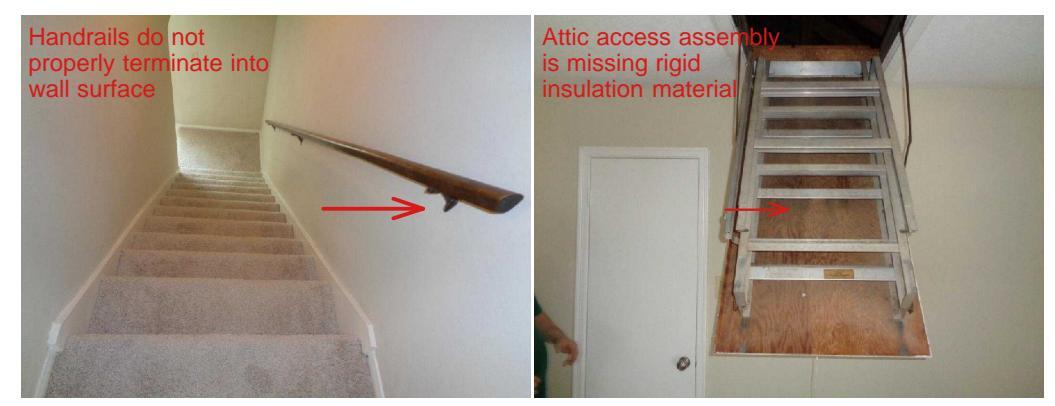
I. Stairways (Interior and Exterior) - Comments: - Carpeted stairs with wood handrails, - Handrail does not properly terminate into the wall (required) This requirement is to prevent clothing (shirt/coat sleeves) from catching on the end of the handrail and result in a fall or bodily injury - needs repair.

- Attic stairway assembly does not have the rigid insulation material (required). Insulation on the attic stair assembly keeps conditioned air from escaping into the attic space - needs repair.

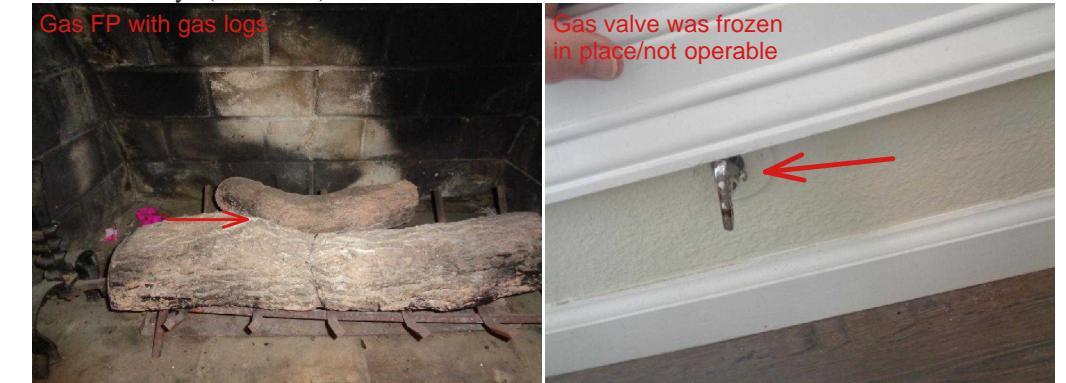
J. Fireplaces and Chimneys - Comments: - Brick, - Fireplace is a gas fireplace with a gas log equipment package. A damper clamp to clamp the damper open should be used with all gas fireplaces and was missing at the time of inspection.

- Gas valve was frozen - Could not be tested.

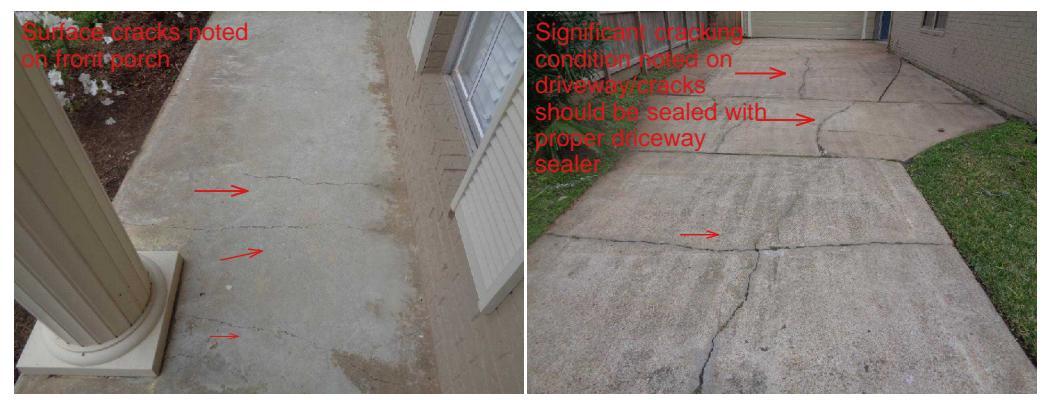
K. Porches, Balconies, Decks, and Carports - Comments: - Concrete, - Cracks noted on driveway surface - these cracks should be sealed with proper driveway sealant to prolong the life of the driveway.

- Surface cracks noted on front porch surface.

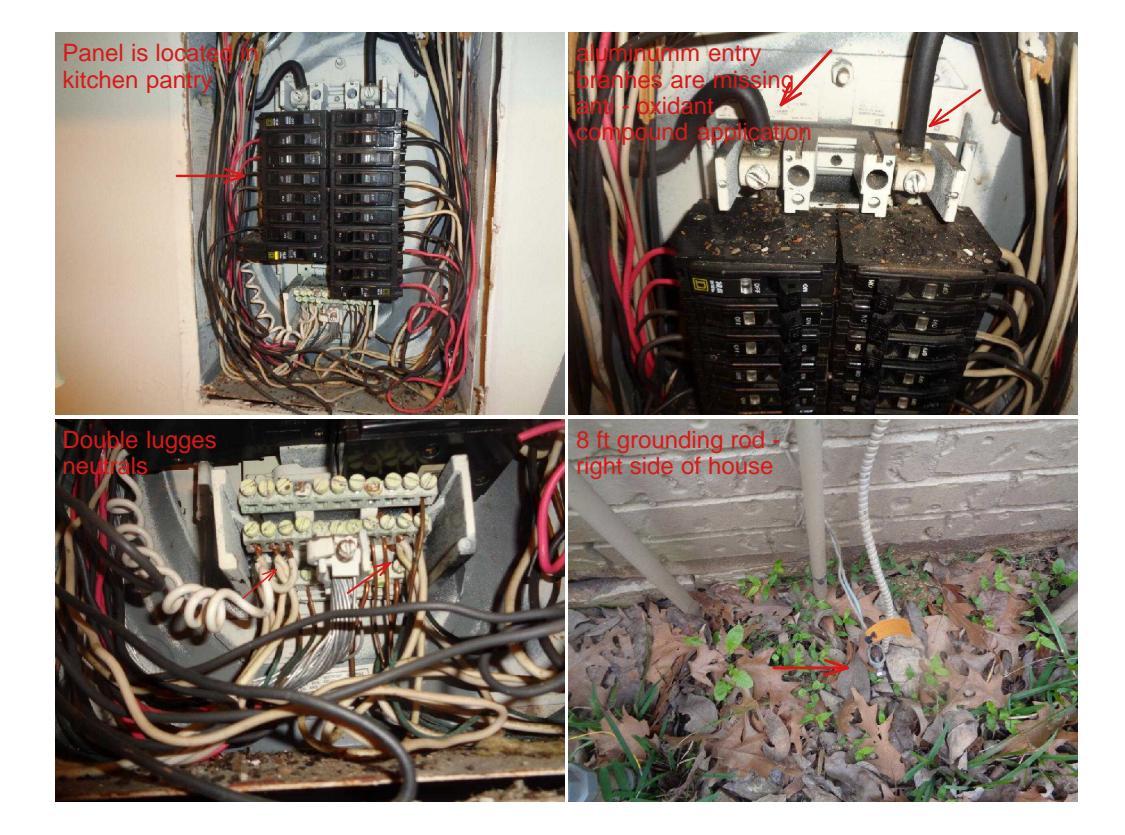
- The panel has aluminum entry branches.

- The panel appears to be missing anti - oxidant compound on the aluminum entry branches. Anti - oxidant compound prohibits oxidation from forming on the aluminum entry branches - needs repair.

- The panel appears to have double lugged neutrals - double lugged neutrals can produce excessive heat. Ideally there should be one lug (wire) per neutral - needs repair.

- The panel does not appear to have the required ARC fault breakers - needs repair.

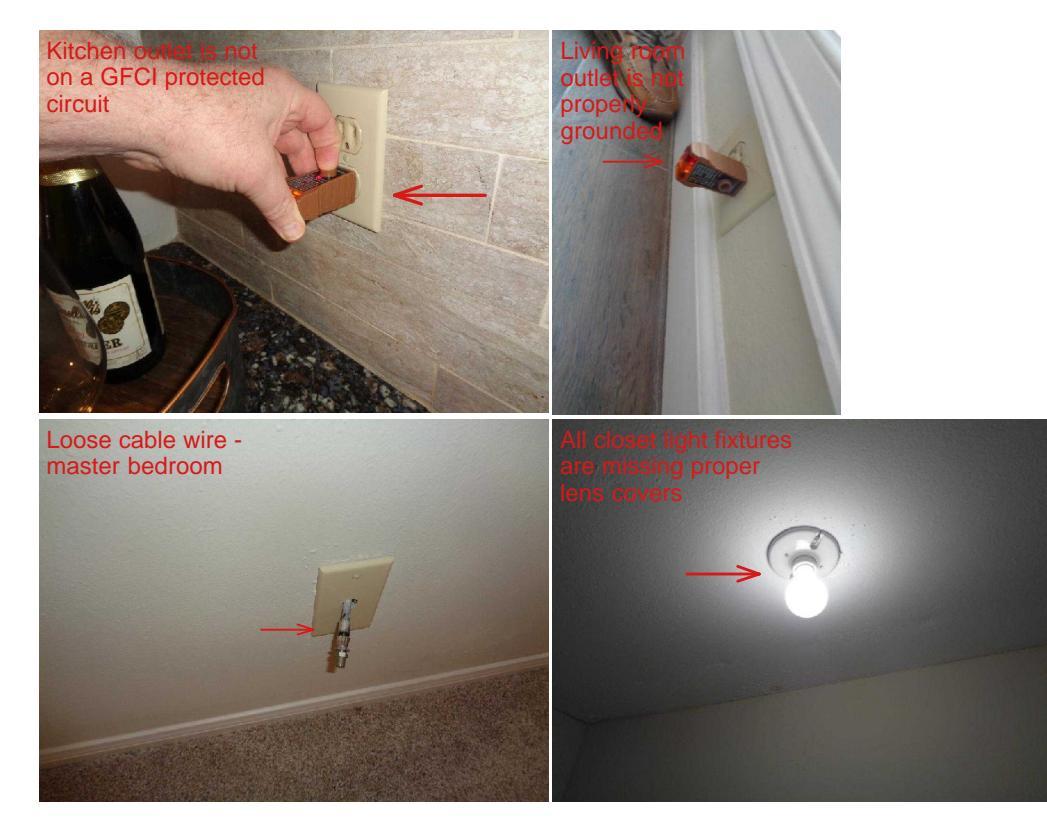
I NI NP D	
B. Branch Circuits, Connected Devices, and F	ixtures
Type of Wiring: - Copper	
Comments: - Copper - Required GFCI protection was over current protection devices be installed (one outlet	non - existent in the kitchen wet areas. It is recommended that these a not protected).
- Open ground circuit (no ground wire) located in livin	g room - needs repair.

- loose cable wire in master bedroom needs repair.
- Closet light fixtures are missing proper lens covers needs repair.
- Dead wall switch noted in upstairs right bedroom closet.
- Exterior switch for garage light fixture is missing proper plastic cover.
- Damage light fixture noted in garage needs repair.
- Florescent light fixture in garage did not engage needs repair.
- Missing cover plate noted in attic needs repair.
- Damaged wiring (repaired with electrical tape) noted in attic needs repair.
- Exterior light fixture on garage did not engage needs repair.

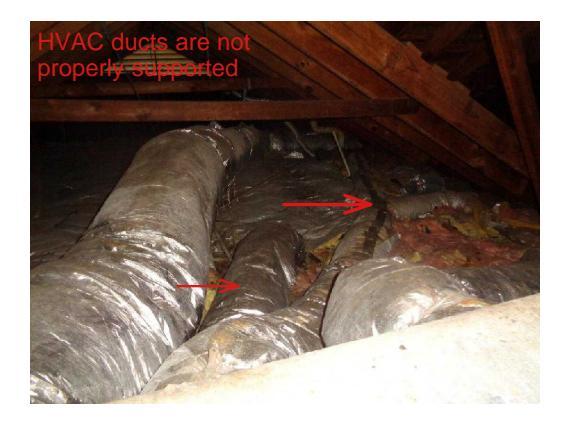
C. Duct Systems, Chases, and Vents - Comments: - Insulated metal duct/insulated flex, - HVAC ducts are not properly supported. Several air ducts are in direct contact with each other which can cause a condition known as "sweating" which is moisture build up inside the actual air ducts - Ducts should be properly separated with insulating material

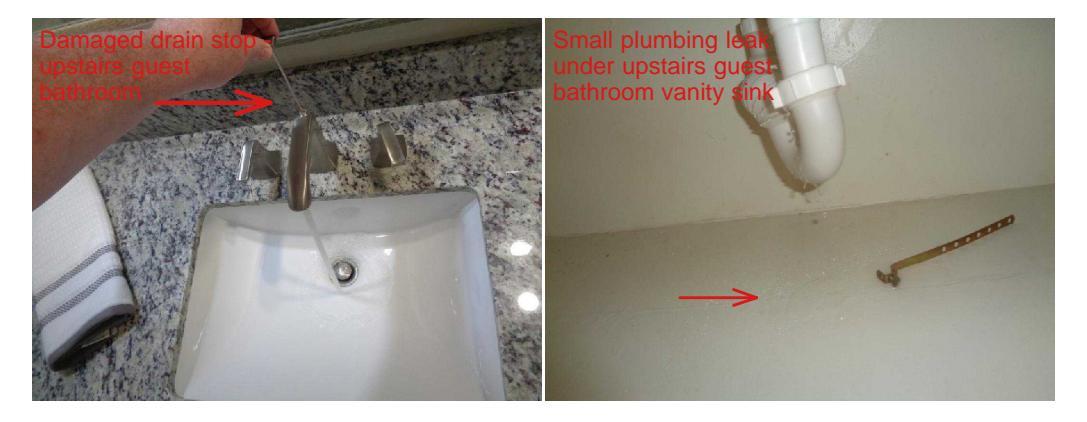
B. Drains, Wastes, and Vents - Comments: - PVC, - Damaged drain stop noted on upstairs guest bathroom vanity sink - needs repair.

- Leak noted in vanity sink drain pipe under counter - needs repair.

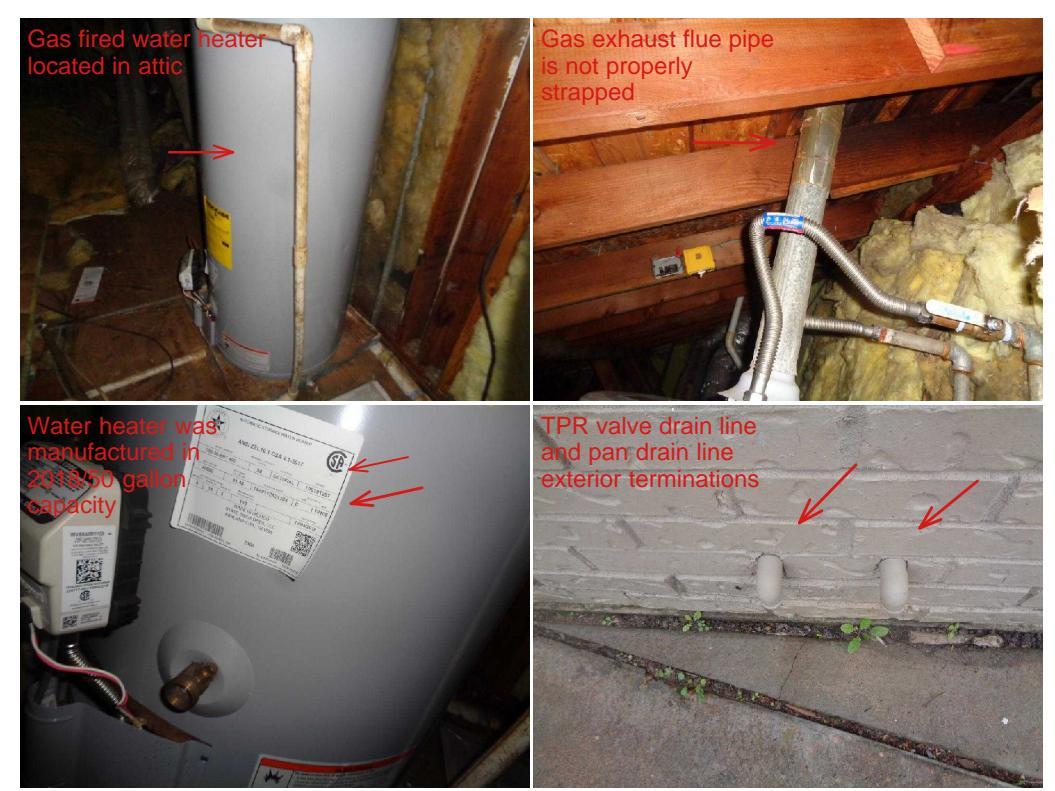
- The water heater was manufactured in 2018. - Support straps missing or not properly installed - needs repair.

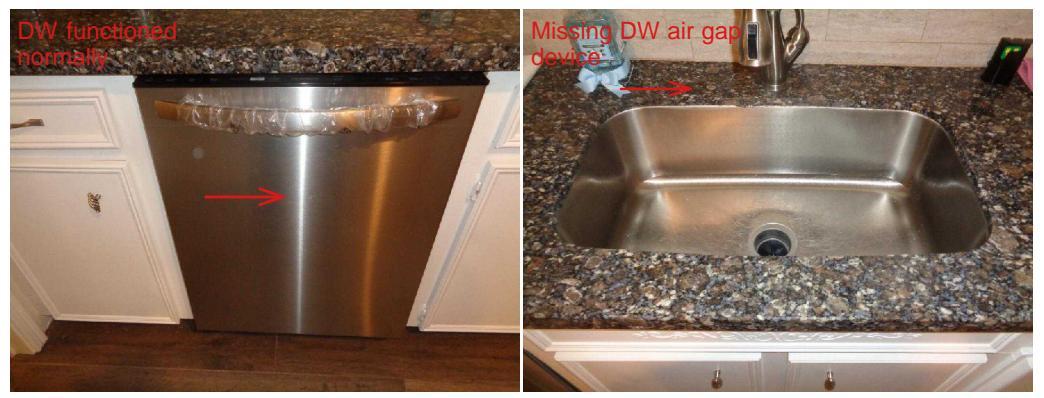
- Dishwasher is missing an air gap or high loop device. These devices are designed to prevent gray water from the dishwasher from contaminating potable (drinking water).

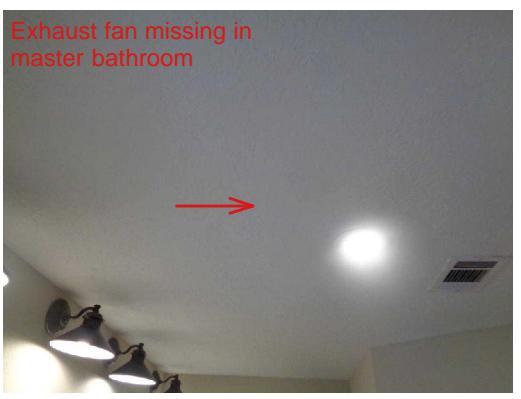
F. Mechanical Exhaust Vents and Bathroom Heaters - Comments: - N/A, - Vent fan missing in master bathroom.

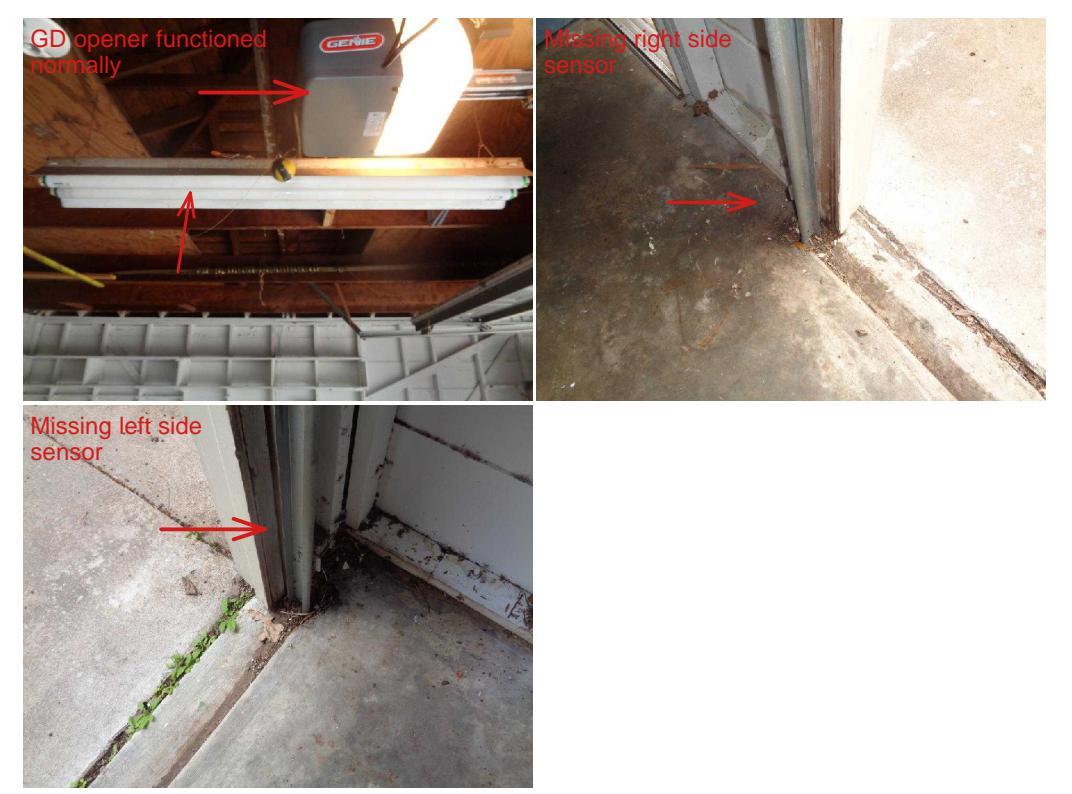
G. Garage Door Operators - Comments: - Genie, - The garage door safety sensors are missing - The sensors are designed to stop the garage door from closing on any objects or people and are therefore a safety device - needs repair.

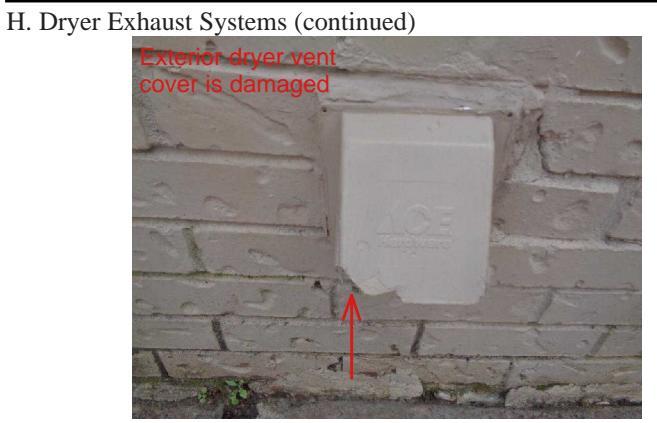
H. Dryer Exhaust Systems - Comments: - Rigid metal, - Exterior dryer cover is damaged and in need of repair.
