Homesmith Home Inspections

321 First St. Houston, TX 77059

PROPERTY INSPECTION REPORT

Prepare	ed For:	Sam Jones		
Concer	ning:	321 First St. Houston	, TX 77059	
Inspect	ion Date:	04/18/2020		
By:	Inspector N Signature:	lame: Todd Duff	License Number: 21107	Date: 11/01/2014
	Sponsoring	Inspector: N/A	License Nu	mber 21107
	Phone: 713	-256-2498	E-Mail: ins	pector@homesmithhomeinspections.com

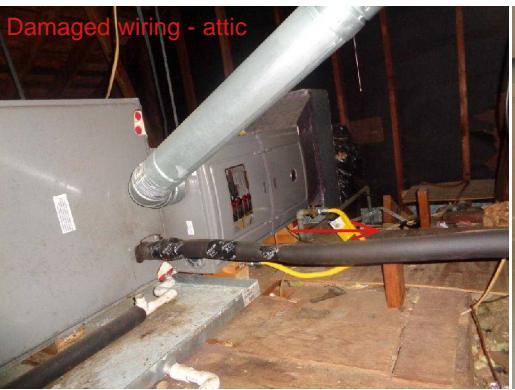
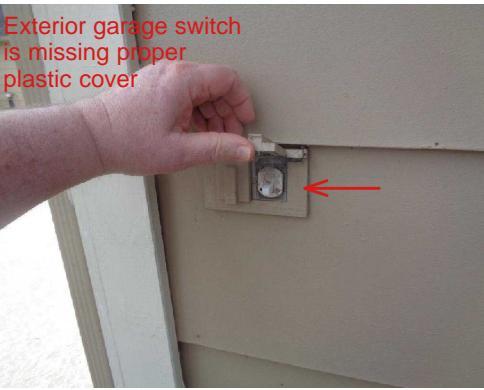
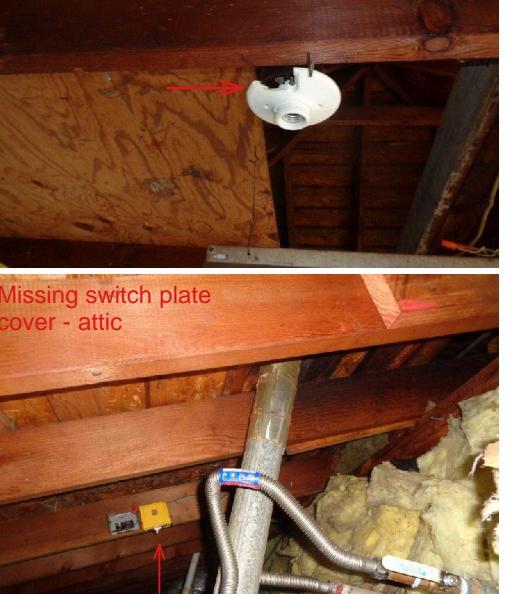
B. Branch Circuits, Connected Devices, and Fixtures (continued)
Dead switch - upstairs
right side bedroom
closet

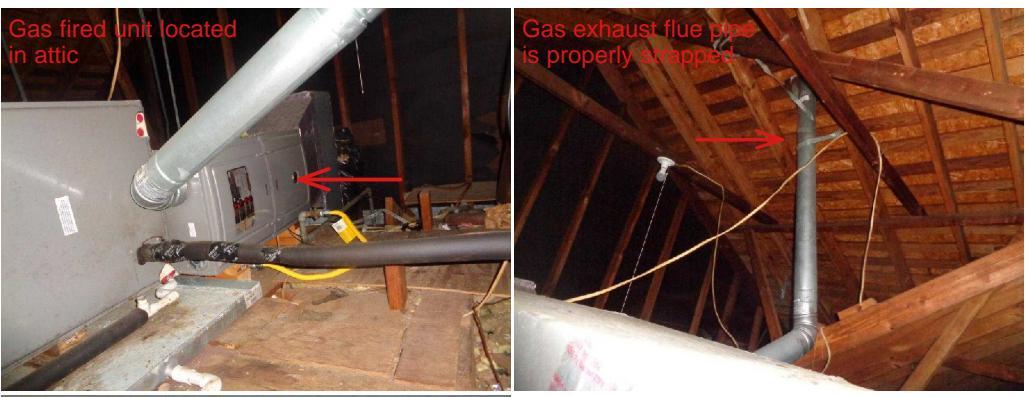
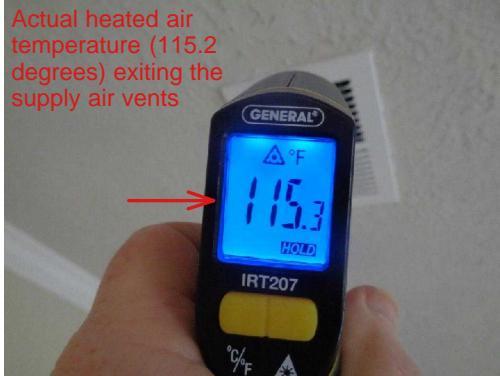
- Heating system appeared to be functioning as designed. Heated air exiting the supply air vents was 115 degrees vs an ambient air temperature of 75 degrees produces a differential of 40 degrees which is acceptable per industry standards.

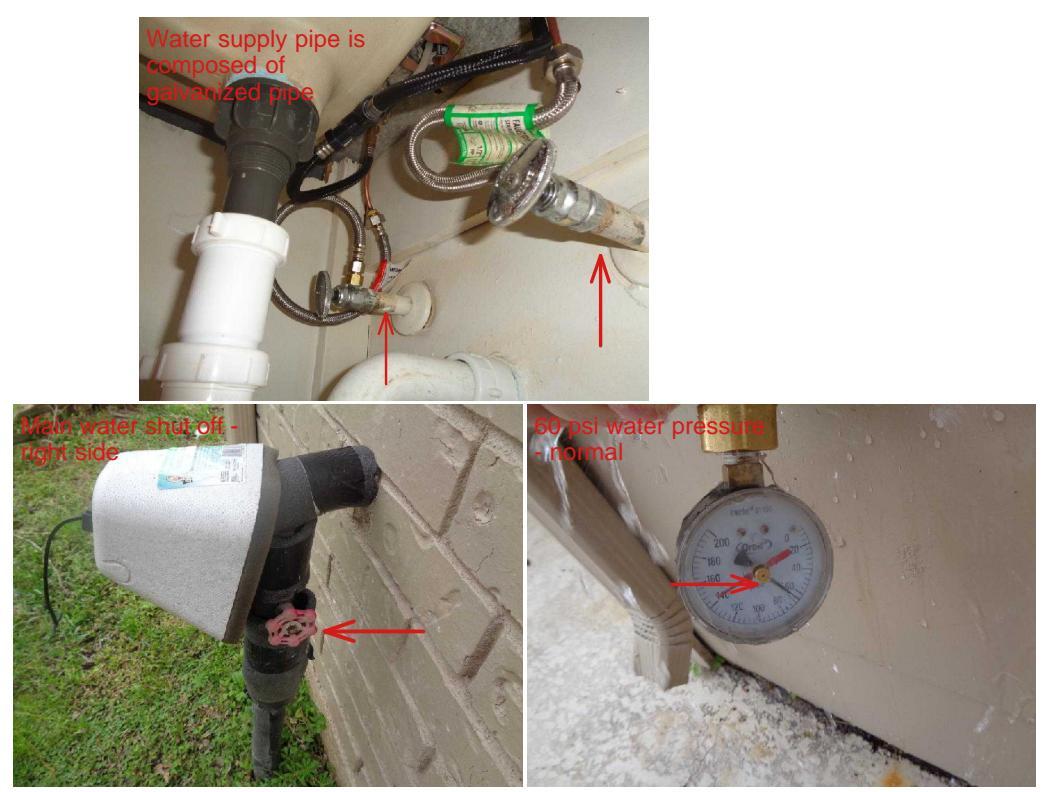
Static water pressure reading: - The water pressure is 60 psi which is within acceptable range of 40 - 80 psi. Comments: - Galvanized - The home has galvanized piping installed. Galvanized pipe is known to corrode over time. Further review by and cost estimates by a licensed and competent plumber are suggested.

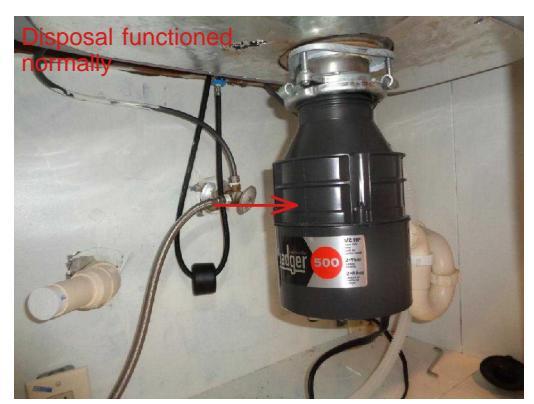
B. Food Waste Disposers - Comments: - In-Sinkerator, - Unit was engaged and appeared to be functioning normally at the time of the inspection.

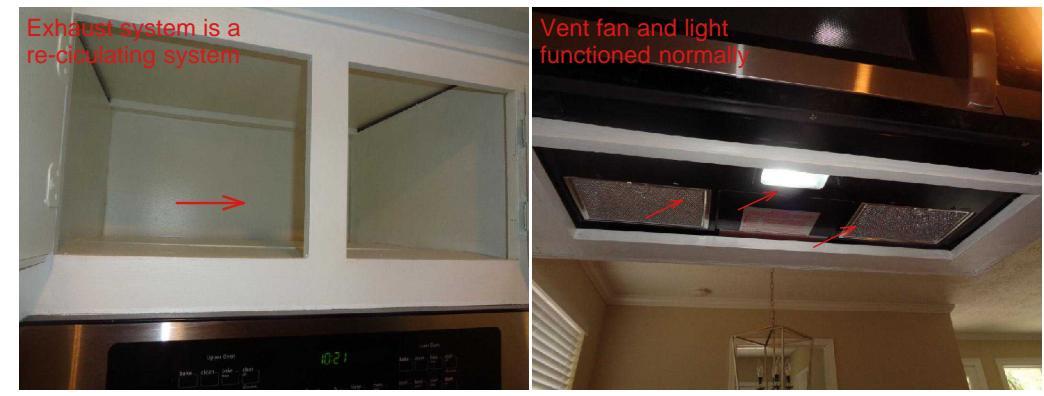
C. Range Hood and Exhaust Systems - Comments: - Frigidaire, - Unit was engaged and appeared to be operating normally at the time of the inspection.

- Vent fan and lights functioned normally.
- Exhaust system is a re-circulating system.

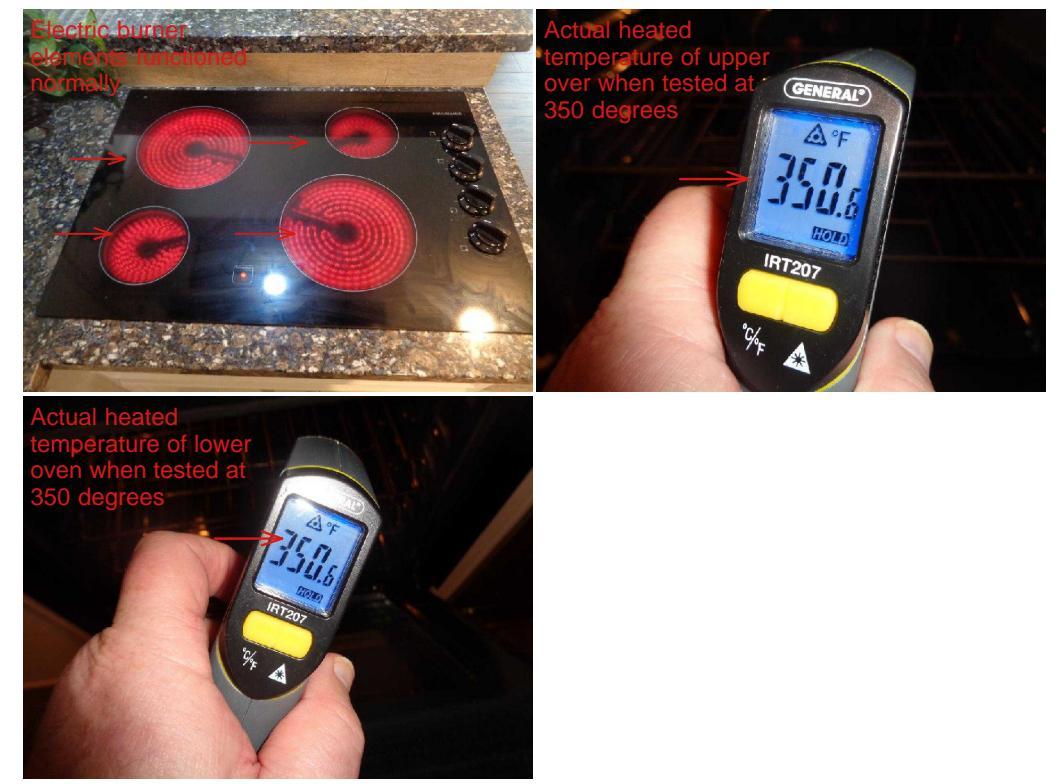
I NI NP D	
D. Ranges, Cooktops, and Ovens - Comments: - Frigidaire,	- All electric burners were engaged and appeared to be
functioning normally at the time of the inspection.

- Both ovens were engaged and tested the temperature at 350 degrees. The test thermometer showed a 0 degree differential which is within tolerance levels (25 degrees).

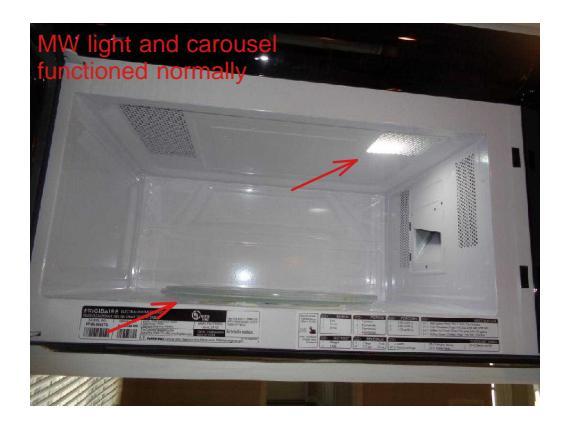
E. Microwave Ovens - Comments: - Frigidaire, - Unit was engaged and appeared to be operating normally at the time of the inspection.

- Carousel and light functioned normally.
