# Home Inspection Report

6543 First Ave. Missouri City, TX 77459

# PROPERTY INSPECTION REPORT

**Inspection Date:** 05/02/2020

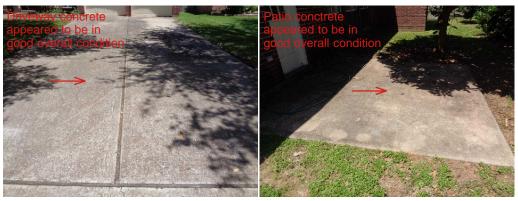
**K. Porches, Balconies, Decks, and Carports** - Comments: - Concrete, - Driveway, porch and patio surfaces appeared to be in good overall condition.

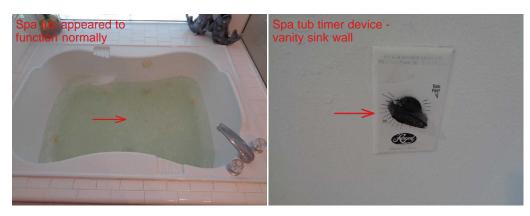
**D. Hydro-Massage Therapy Equipment** - Comments: - Spa Tub, - Spa tub was engaged and appeared to be operating properly at the time of the inspection.

- The spa tub dedicated GFCI device is located on vanity sink wall. Device was tested and successfully engaged.
- Spa tub timer device is located on vanity sink wall.
