Home Inspection Report

789 Elm St. Richmond, TX 77407

PROPERTY INSPECTION REPORT

Inspection Date: 02/19/2020

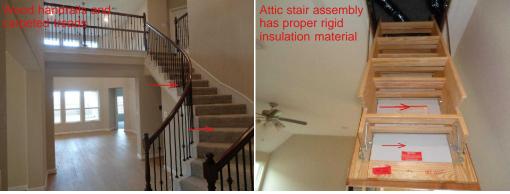
- I. Stairways (Interior and Exterior) Comments: Carpeted stairs with wood handrails, Stairway components appeared to be functioning per designed and installed.
 - Attic stairway assembly does have the rigid insulation material (required). Insulation on the attic stair assembly keeps conditioned air from escaping into the attic space.

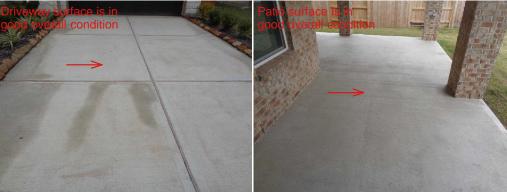
K. Porches, Balconies, Decks, and Carports - Comments: Brick/concrete, - All porch and patio surfaces appear to be in good overall condition.

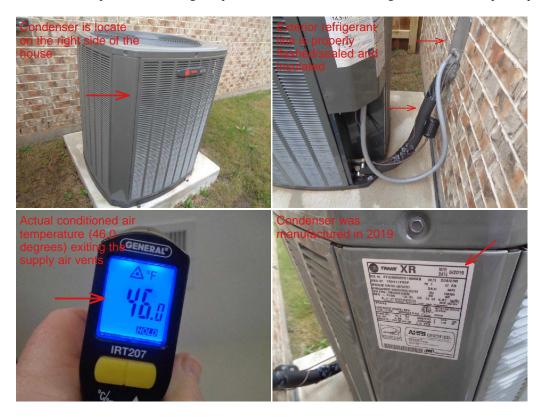
Comments: - Trane - The condenser is located on the right side of the house.

- The condenser was manufactured in 2019.
- Refrigerant line penetration into the structure appears to be properly flashed/sealed.
- The exterior portion of the refrigerant line appears to be properly insulated.
- The a/c system appeared to be functioning as designed. Cooled air exiting the supply air vents was 46 degrees vs an ambient air temperature of 68 degrees produces a differential of 22 degrees which is acceptable per industry standards.

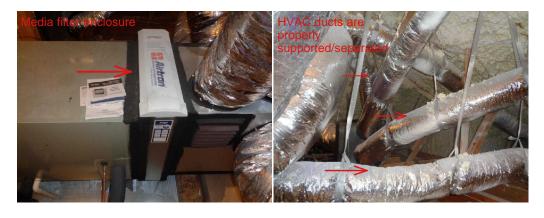
- C. Duct Systems, Chases, and Vents Comments: Insulated flex, The HVAC ducts appear to be properly supported. No crimping was observed.
 - Properly supported air ducts prohibit crimps in the duct material which will inhibit adequate air flow through the ducts.
 - The HVAC system has a media filter that needs to be changed according to Manufacturer's instructions.

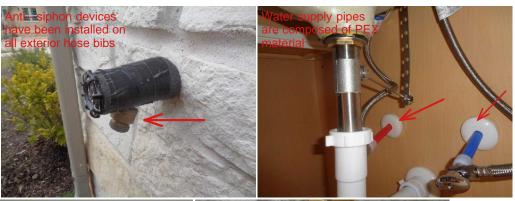
Static water pressure reading: - The water pressure is 60 psi which is within acceptable range of 40 - 80 psi. Comments: - PEX - Required anti - siphon devices appear to have been installed.

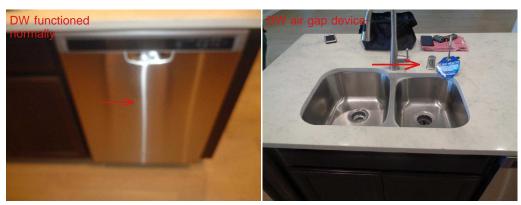
A. Dishwashers - Comments: - Whirlpool, - Dishwasher was turned on to full normal cycle and appeared to be functioning normally at the time of the inspection.

- Dishwasher has an air gap or high loop device. These devices are designed to prevent cross contamination of dishwasher discharge water with potable (drinking) water.

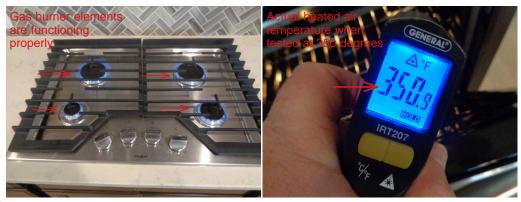
D. Ranges, Cooktops, and Ovens - Comments: - Whirlpool, - All gas burners engaged and appeared to be functioning normally at the time of the inspection.

- The oven was engaged and tested the temperature at 350 degrees. The test thermometer showed a 0 degree differential which is within tolerance levels (25 degrees).
